NORTH FORK

County Road 43

Colorado Flood Recovery: Watersheds and Natural Resources

River Channel Restoration

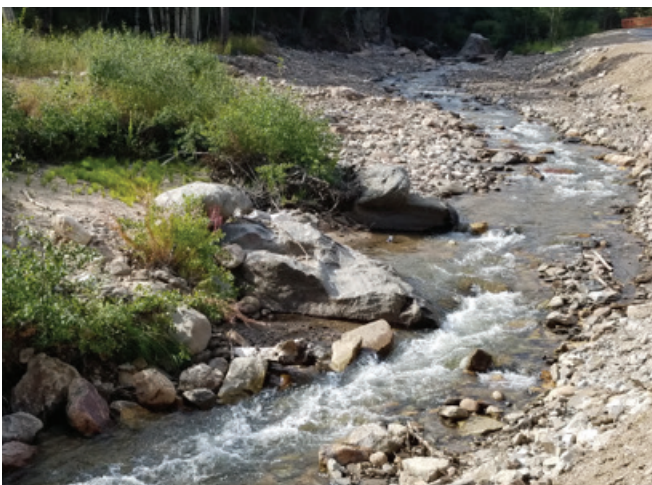
Floodplain grading and boulder placement.

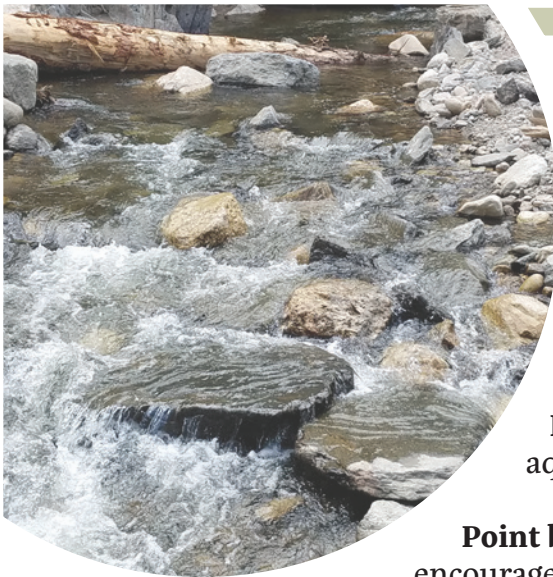
Riffle/Pool Sequencing

Riffle-pool sequences were constructed throughout the project reach to provide a heterogeneous physical environment that can be used by a diversity of organisms (pictured at left). They provide a refuge from high velocity waters and extreme temperatures, and promote habitat complexity by offering diverse areas of cover, food, as well as spawning and rearing areas.

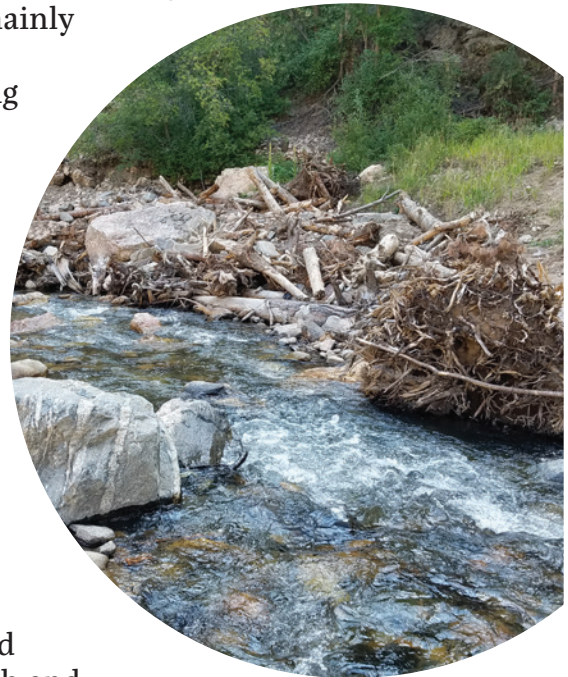
Large Woody Debris

Large woody debris was utilized in several areas for a variety of purposes, including floodplain roughness, bank stabilization, energy dissipation, and habitat complexity (pictured at right). Root wads face upstream on the outside of meander bends to dissipate energy and create micro-habitats.

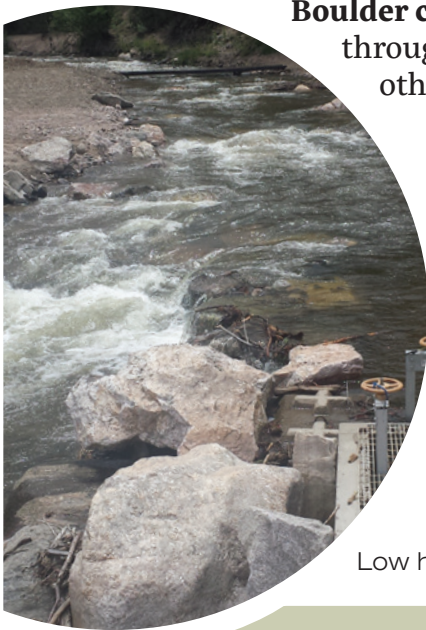
Grade control and drop structures were built to set the elevation of the streambed to reduce the likelihood of severe scour, as well as to aid in the maintenance of riffle and pool bed features. The pools created by these structures provide cover for fish and other aquatic organisms. Low head boulder structures were used for fish friendly irrigation diversions (pictured at left).

Low head boulder structures for fish-friendly irrigation diversions
